# Christchurch Bay & Harbour FCERM Strategy

Defence Condition Report

Bournemouth, Christchurch and Poole (BCP) Council,  
New Forest District Council (NFDC) and the Environment  
Agency

April 2024

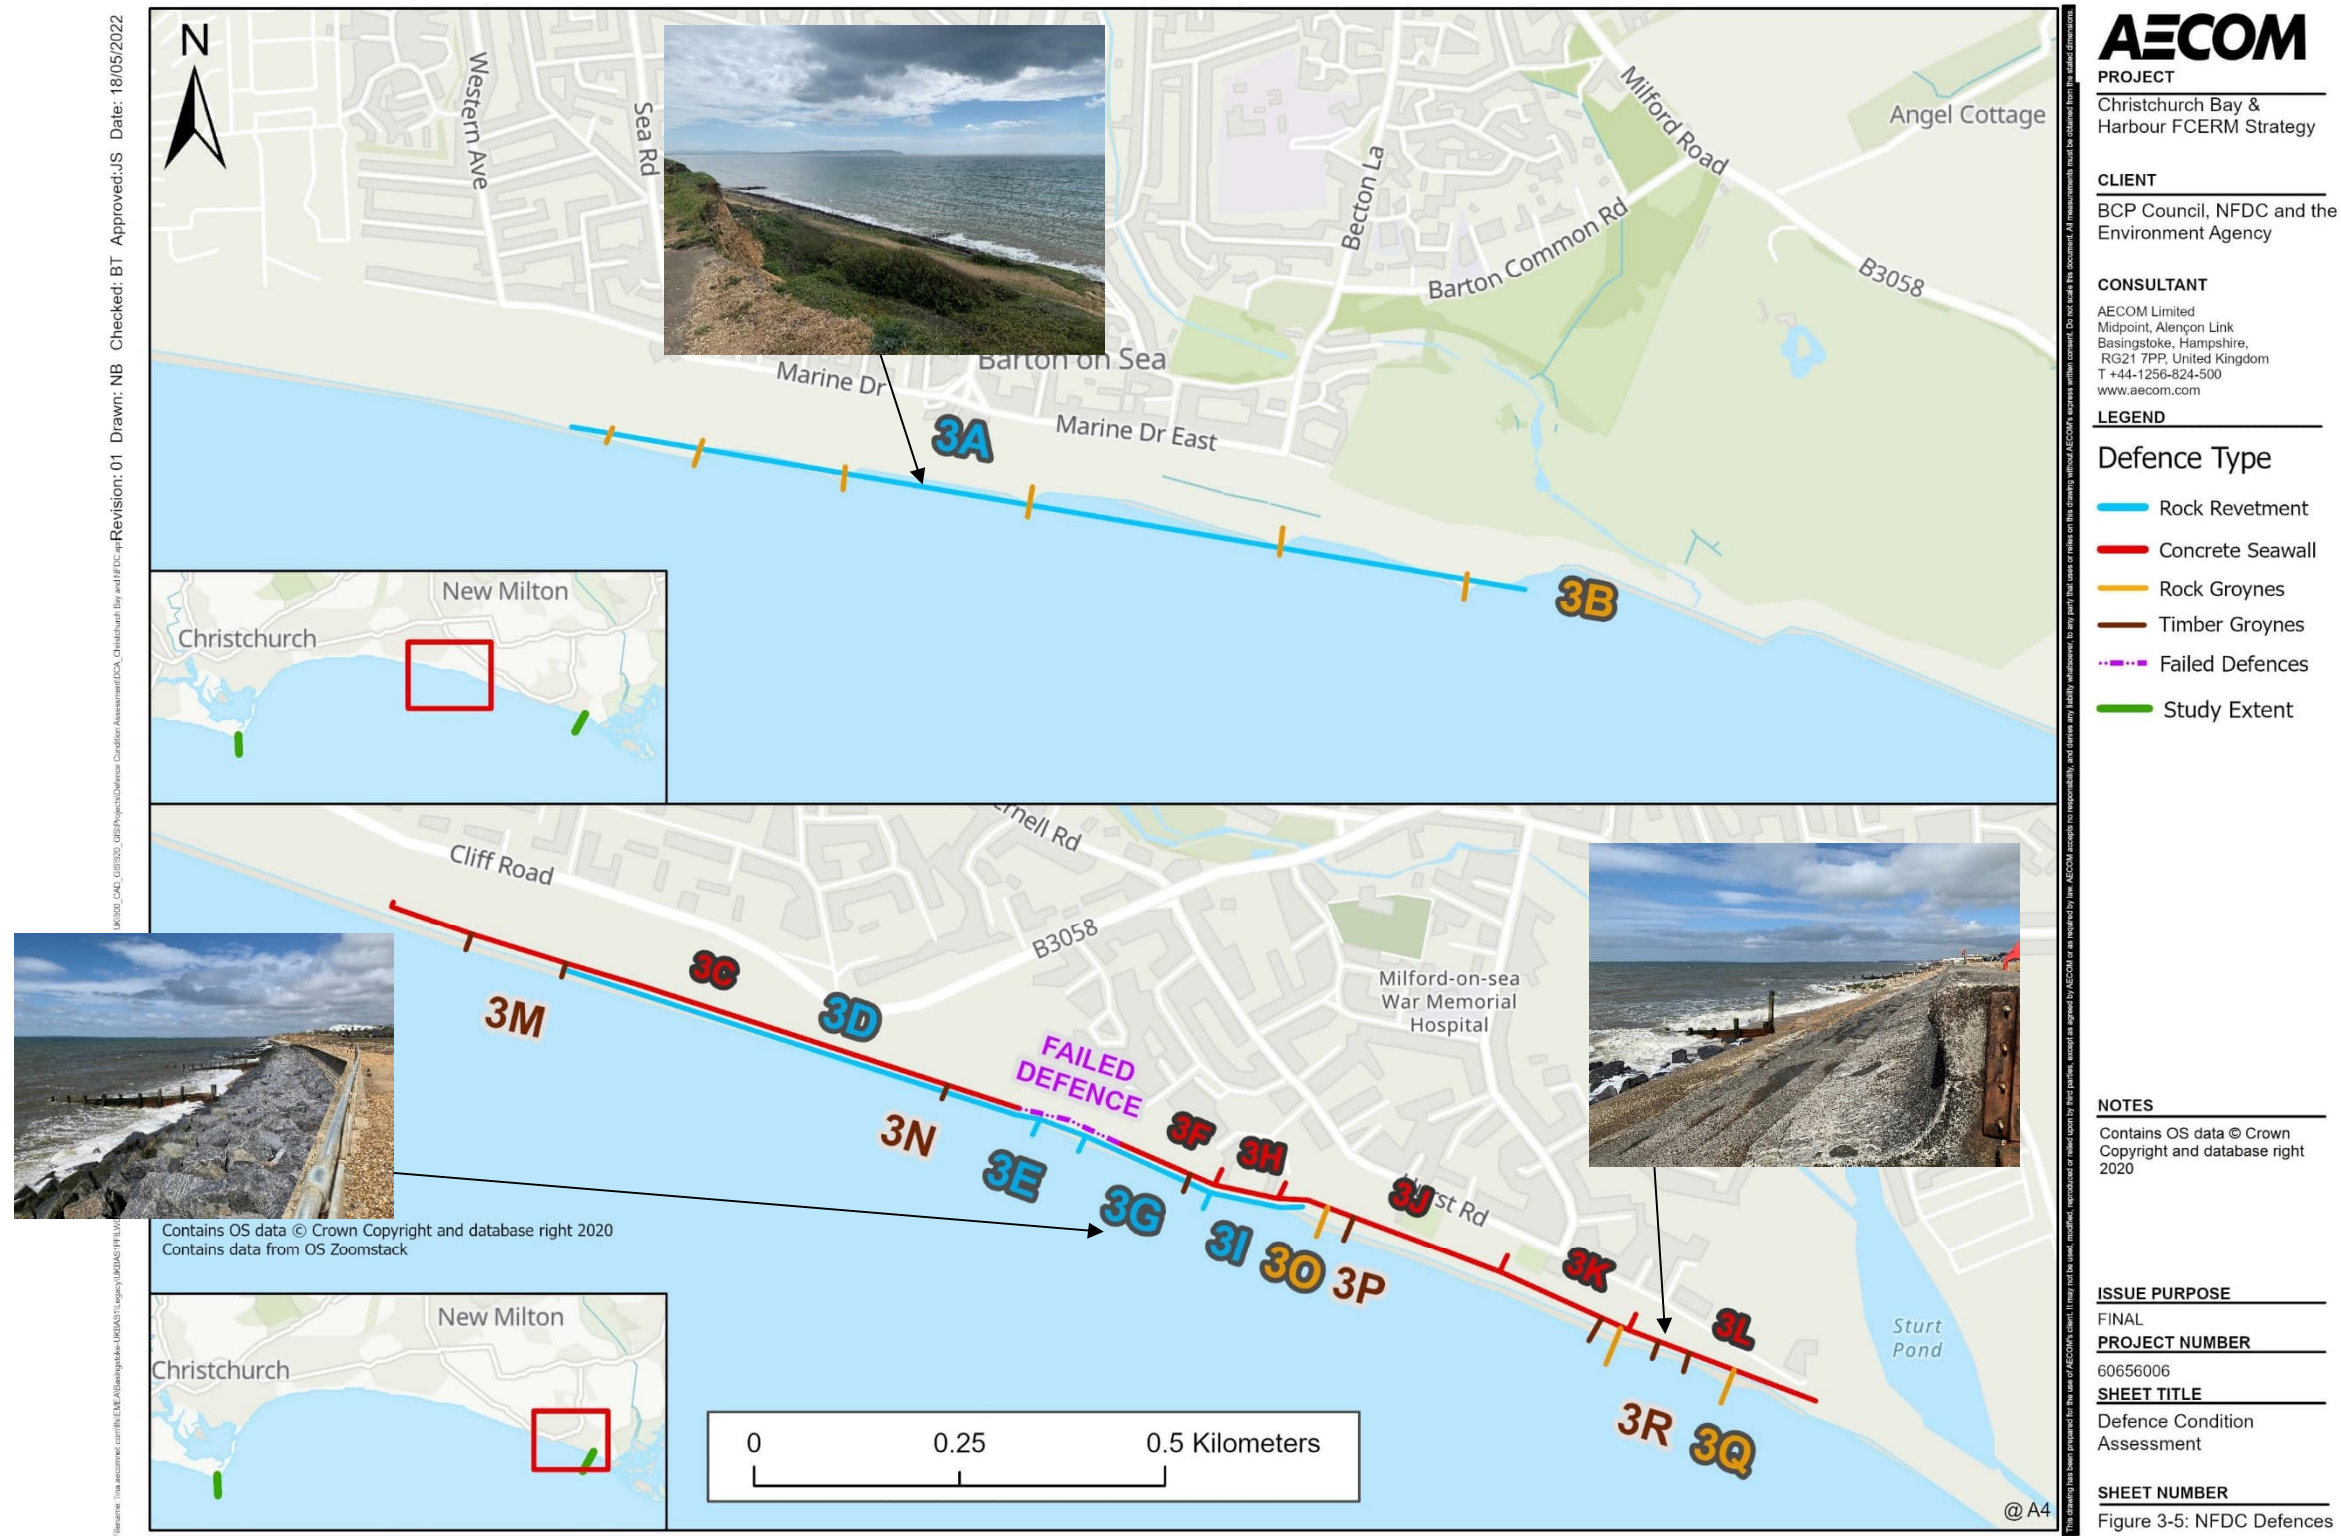
Figure 3-5: Defence Types in NFDC area (Frontage ID 3A – 3R)

Note that there is a section of failed concrete seawall, located between Frontage 3C and 3F (now fronted by a newly installed section of revetment). The failed concrete wall is not included within Table 3-2, but is shown in Figure 3-5.

Frontage ID	Centre X	Centre Y	Summary of Defence Type	Section Length (m)	Maintainer	Defence Grade	Residual Life	Notes
3A	424000	92810	Rock Revetment	1,830	Local Authority	2/3	10 – 15 years	These structures are vulnerable to ongoing ground movement.
3B	424000	92810	Rock Groyne (x6)	380	Local Authority	2/3/4	<10 years	
3C	428130	91610	Concrete Seawall	800	Local Authority	3	<10 years	The integrity of the section of the Seawall not protected by rock revetment is sensitive to the presence and supply of beach material which is subject to coastal conditions.
3D	428260	91560	Rock Revetment	630	Local Authority	3	10 – 15 years	
3E	428570	91460	Rock Revetment	60	Private Land (maintainer unknown)	1	20 years	Urgent works were undertaken at this site by NFDC during 2020, through its powers as Coastal Protection Authority.
3F	428700	91420	Concrete Seawall	130	Private Land (maintainer unknown)	4	<10 years	Urgent works were undertaken at this site by NFDC during 2020, through its powers as Coastal Protection Authority.

3G	428670	91420	Rock Revetment	170	Private Land (maintainer unknown)	1	20 years	Urgent works were undertaken at this site by NFDC during 2020, through its powers as Coastal Protection Authority.
3H	428790	91380	Concrete Seawall	80	Local Authority	2	<10 years	
3I	428820	91370	Rock Revetment	110	Local Authority	2	10 – 15 years	
3J	428970	91340	Concrete Seawall	300	Local Authority	2	<10 years	The integrity of the section of the Seawall not protected by rock revetment is sensitive to the presence and supply of beach material which is subject to coastal conditions.
3K	429180	91250	Concrete Seawall	170	Local Authority	2	<10 years	The integrity of the section of the Seawall not protected by rock revetment is sensitive to the presence and supply of beach material which is subject to coastal conditions.
3L	429370	91170	Concrete Seawall	240	Local Authority	2/3	<10 years	The integrity of the section of the Seawall not protected by rock revetment is sensitive to the presence and supply of beach material which is subject to coastal conditions.

3M	427910	91670	Timber Groynes (x2)	50	Local Authority	2/3	<10 years	Stability of the timber groynes is heavily reliant on the presence and supply of beach material which is subject to coastal conditions. Without regular ongoing maintenance these groynes are expected to fail in a short space of time.
3N	428590	91460	Timber Groynes (x8)	180	Local Authority	2/3/4	<10 years	Stability of the timber groynes is heavily reliant on the presence and supply of beach material which is subject to coastal conditions. Without regular ongoing maintenance these groynes are expected to fail in a short space of time.
3O	428890	91350	Rock Groyne (x1)	40	Local Authority	2	<10 years

Frontage ID	Centre X	Centre Y	Summary of Defence Type	Section Length (m)	Maintainer	Defence Grade	Residual Life	Notes
3P	429060	91280	Timber Groynes (x10)	300	Local Authority	2	<10 years	Stability of the timber groynes is heavily reliant on the presence and supply of beach material which is subject to coastal conditions. Without regular ongoing maintenance these groynes are expected to fail in a short space of time.
3Q	429310	91190	Rock Groynes (x2)	80	Local Authority	3	<10 years	
3R	429310	91190	Timber Groynes (x2)	70	Local Authority	2/3/4	<10 years	Stability of the timber groynes is heavily reliant on the presence and supply of beach material which is subject to coastal conditions. Without regular ongoing maintenance these groynes are expected to fail in a short space of time.

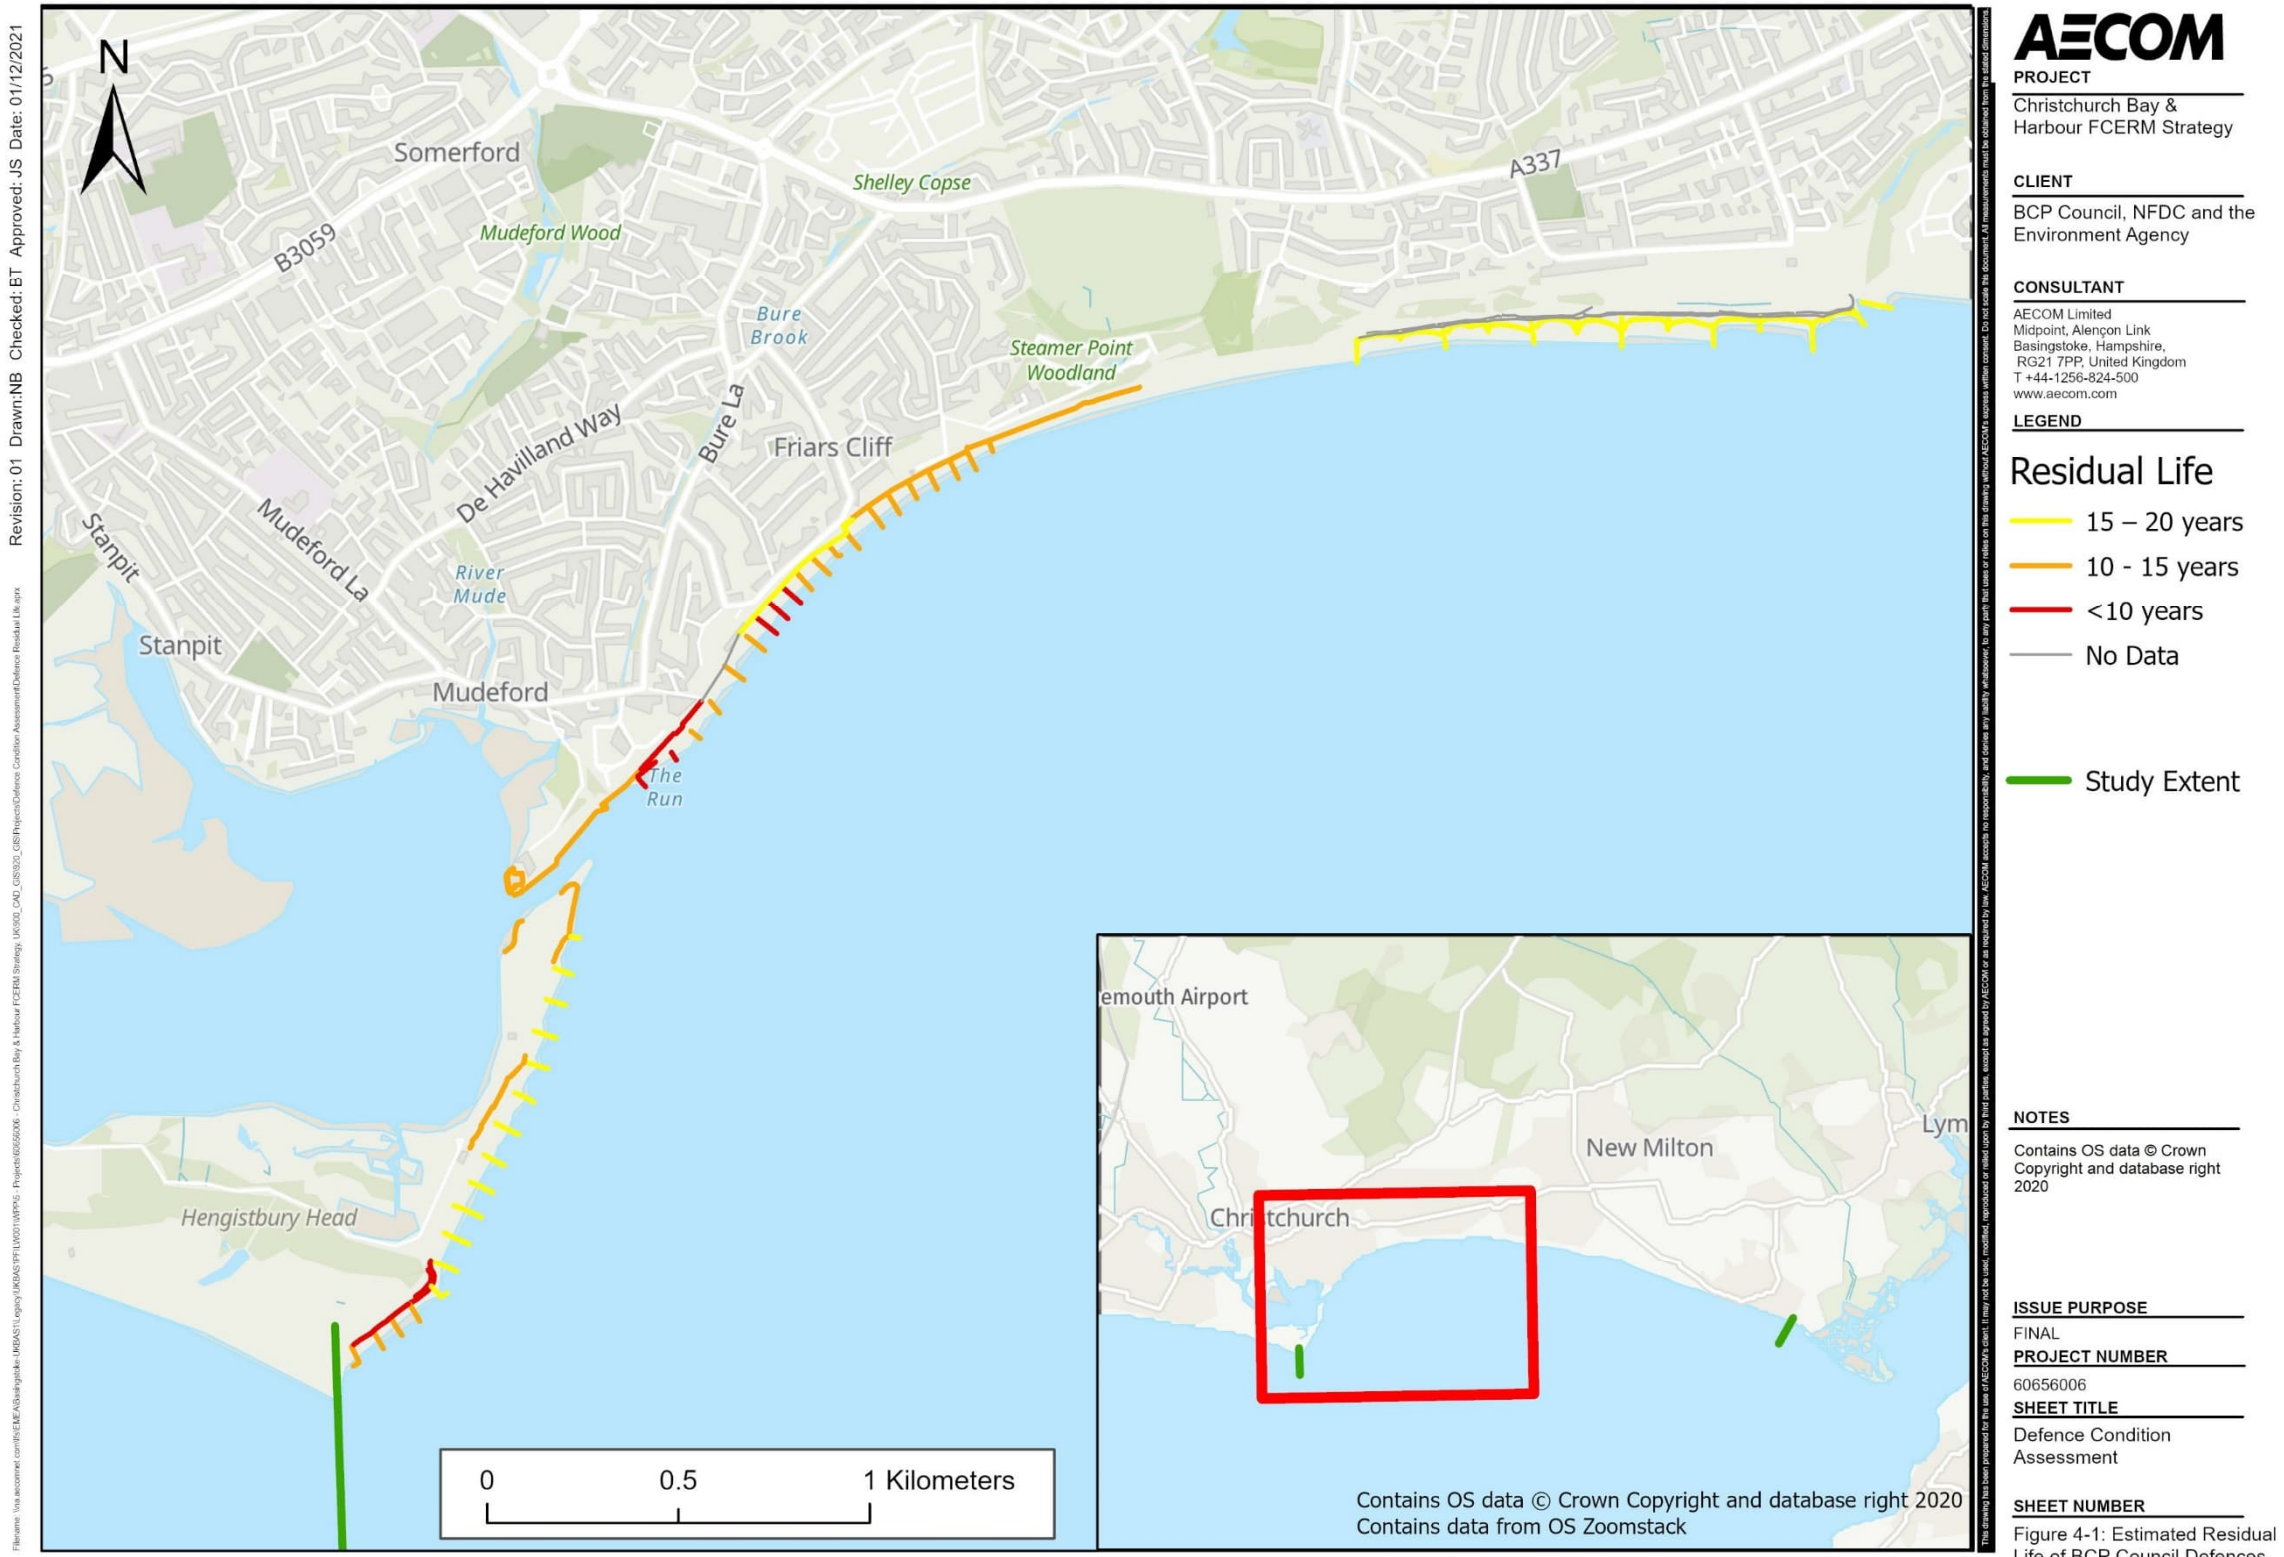
Figure 4-1: Estimated Residual Life of BCP Council Defences (Christchurch Bay), excluding maintenance

Based on this information, the following frontages have been identified as priority areas which warrant further attention from the landowners and will also require consideration as part of the Strategy. These priority areas have been identified where extensive lengths of defence are in a poor condition with an estimated residual life < 10 years.

- Frontages 1A, 1B, 1C – defences at Hengistbury Head, including gabions, rock armour and concrete revetment;
- Frontages 1I, 1J, 1K 1L, – timber and rock groynes at Mudeford and Friars Cliff, and Friars Beach seawall and promenade; and,
- Frontages 3H to 3R – defences at Milford on Sea including concrete seawall, rock revetment timber groynes and rock groynes.
