# Christchurch Bay & Harbour FCERM Strategy

Defence Condition Report

Bournemouth, Christchurch and Poole (BCP) Council,  
New Forest District Council (NFDC) and the Environment  
Agency

April 2024

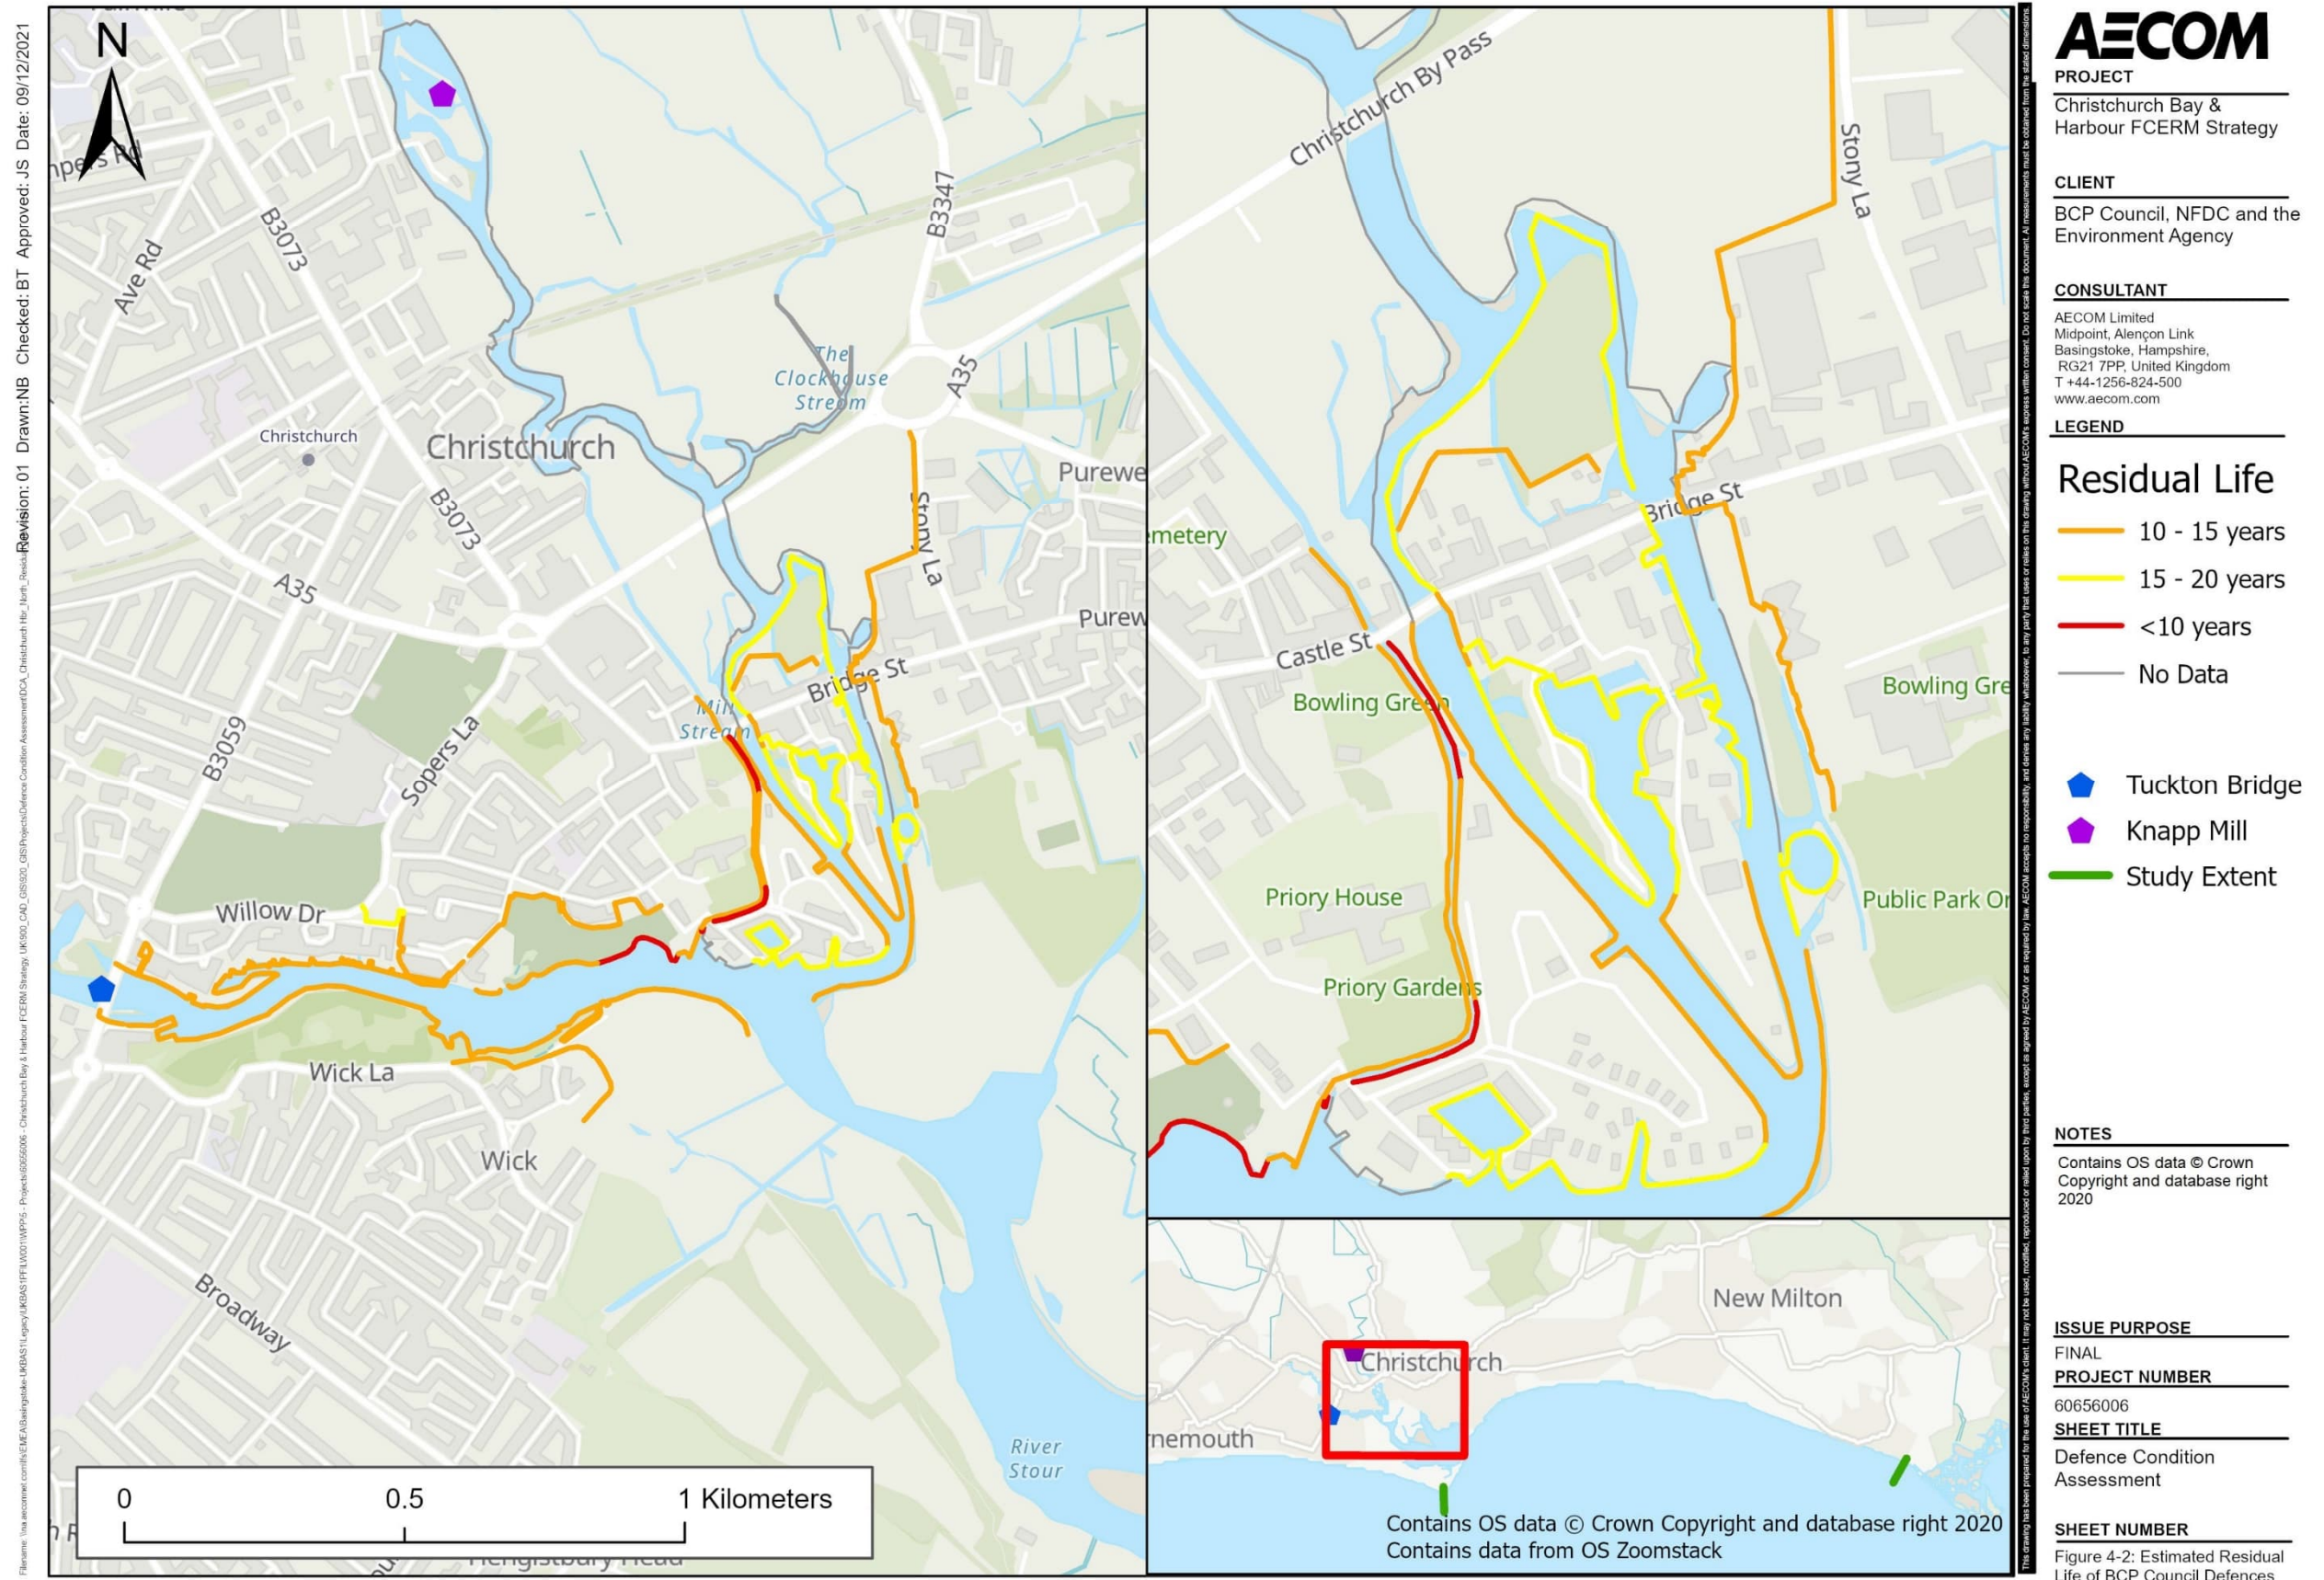
Figure 4-2: Estimated Residual Life of BCP Council Defences (Christchurch Harbour - North), excluding maintenance

The estimated residual life of the defences within the Strategy area are summarised in Figure 4-1 to Figure 4-4 (overleaf).
